# TRENDS OF COMMUNITY-BASED INTERVENTIONS ON SUSTAINABLE WATERSHED DEVELOPMENT IN THE ETHIOPIAN HIGHLANDS, THE GUMARA WATERSHED

Meseret Addissie<sup>1</sup> and Gashaw Molla<sup>1</sup>

<sup>1</sup>Debre Tabor University

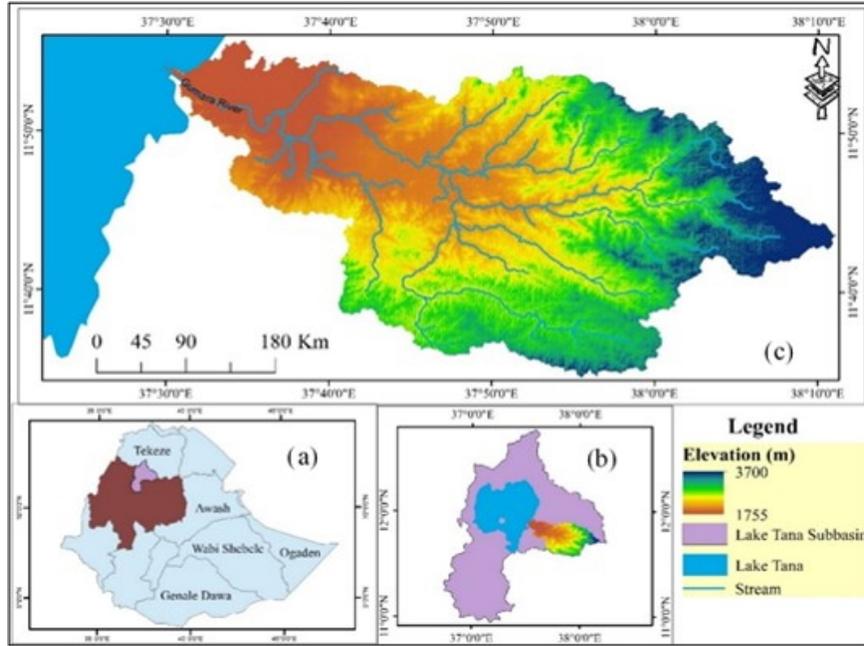
The Gumara watershed is found in the North-West part of Ethiopia in the Amhara National Regional State, South Gondar Zone at 624 km north of Addis Ababa (Figure 1). This watershed is situated in the eastern part of the Lake Tana sub-basin. Astronomically, the watershed lies between  $11^{\circ} 34' 41.41''$  N and  $11^{\circ} 56'36.95''$  N latitude to  $37^{\circ} 29' 30.48''$  E and  $38^{\circ} 10' 58.01''$  E longitude (Figure 1). Gumara watershed has an undulating topography ranging from 1755 m a.s.l. near Lake Tana to 3700 m a.s.l. at mount Guna (Figure 2a). The topography of the area has an important contribution to the surface runoff and soil erosion processes (Yibeltal, 2020). The steep slope in the upper part and gentle slope in the downstream characterizes the watershed (Figure 2b). The area is dominated by unimodal rainfall mainly concentrated from June to September. The mean annual total rainfall ranges from 1257 to 1544 mm. Based on the 2018 land use land cover classification, cultivated land constitutes the largest share of the watershed with 97.5% (1509 km<sup>2</sup>). Grazing and forest land comprise 1.4% (22 km<sup>2</sup>) and 1.2% (19 km<sup>2</sup>), respectively. Gumara watershed experienced large-scale land use/cover dynamics. Cultivated and settlement land expanded by 21.99% whereas forest, shrub, grassland, and wetland declined by 85%, 91%, 76%, and 73% over the period 1985–2016, respectively (Wubie et al., 2016) . Although there is a decline in natural vegetation, there is an expansion of some exotic tree species like eucalyptus on privately owned farm plots. The major means of livelihood in the area is subsistence-mixed agriculture (crop and livestock production).

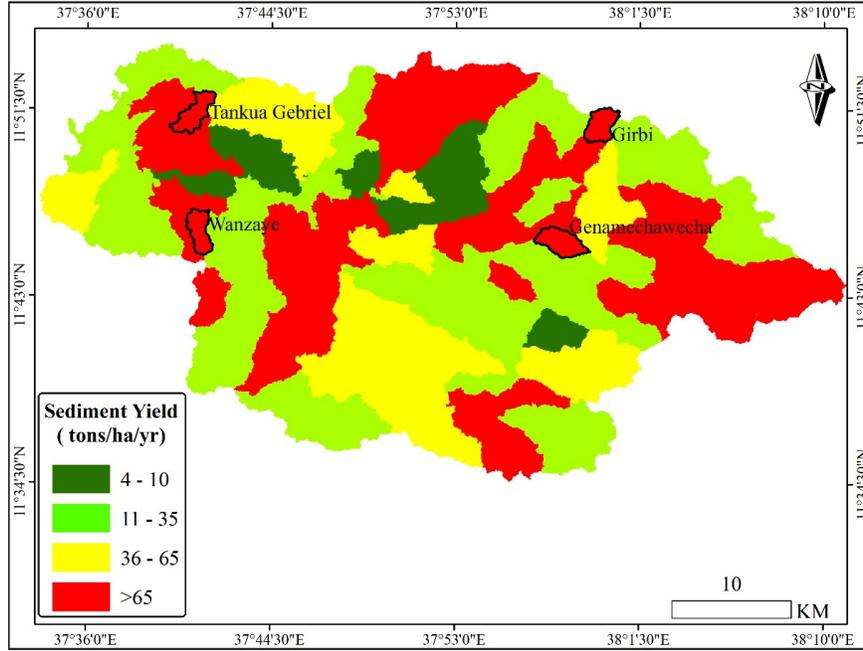
Therefore, the SWAT model output provides the amount of soil loss in the watershed. Based on the given values greater than  $65 \text{ t ha}^{-1} \text{ yr}^{-1}$  of sediment loss were considered for the research. Although a greater number of sub-watersheds had soil loss greater than  $65 \text{ t ha}^{-1} \text{ yr}^{-1}$ , the research gave priority to those watersheds having access to roads and their proximity to agriculture offices. Besides, since the watersheds lie under the four districts, due consideration was given to include agriculture officers as a source of information assuming that different modes of watershed implementation approach employed. Finally, the four selected watersheds located under the four districts (Farta, Fogera and Dera) were, Girbi, Gena-mechawocha, Tankua Gebriel and Wanzaye (Figure 3).

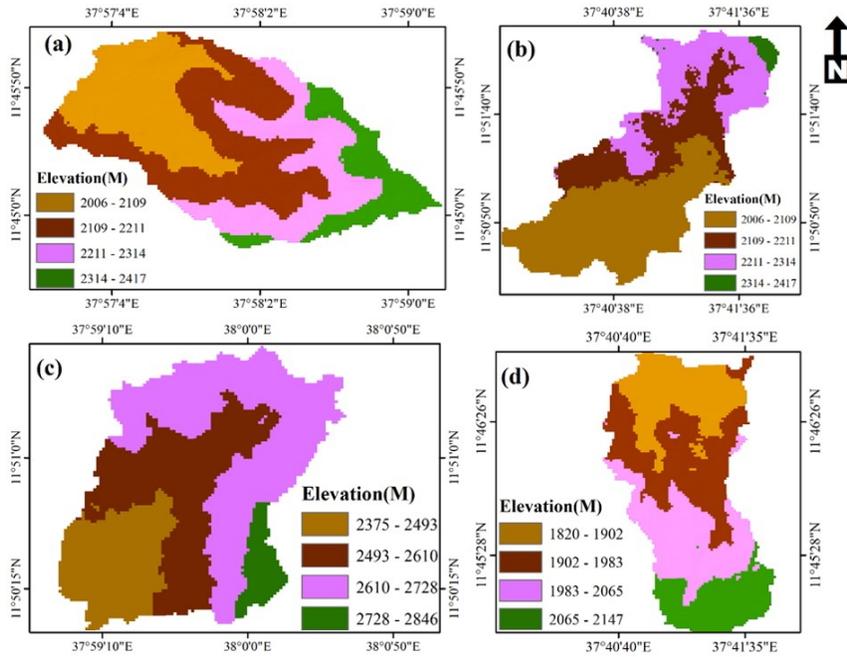
The study was conducted in the Gumara watershed specifically on the selected four sub-watersheds (Figure 4). The watersheds Girbi and Gena-mechawocha are under the Farta district administrative; Tankua Gebriel in Fogera and Wanzaye in Dera districts. The altitude of the selected watersheds ranging from 1800 to 2846 m a.s.l. (Figure 4). These watersheds cover an area of 581.5 ha for Girbi, 695.5 for Gena-mechawocha, 627.1 for Tankua Gebriel and 555.2 ha for Wanzaye.

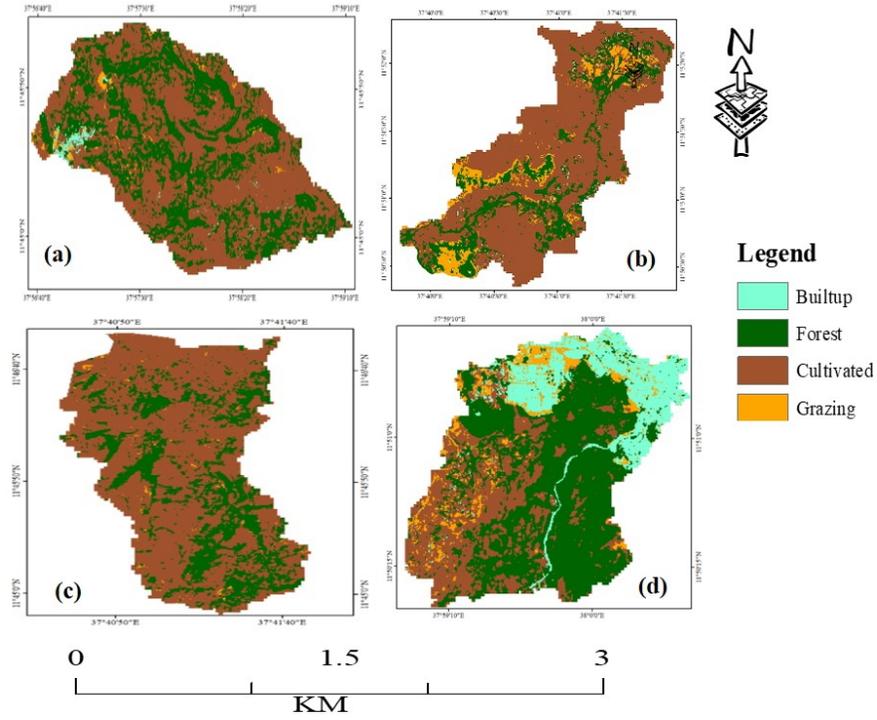
The land use land cover of the four watersheds is shown in figure 5 (Gena-mechawocha (a); Tankua Gebriel (b); Wanzaye (c) and Girbi (d). In these watersheds the land use is classified as built-ups, forests, cultivated and grazing land. The built-ups were hard to identify and were the dispersed rural settlements. The area covered under this land use category indicated greater in Girbi watershed since the tip of the watershed includes parts of the Debre Tabor town (about 101 ha) and followed by Gena-mechawocha (7.4 ha, Figure 5). The area under forest cover, which includes trees planted around homesteads and there is an increasing trend over the past years (Halefom et al., 2019). This is attributable to the afforestation program of the government and planting eucalyptus trees at the household level. The area covered with forests in Girbi and Gena-mechawocha were about 277 and 250 ha, respectively (Table 1). However, in Girbi, almost all are eucalyptus plantations in the hillslopes and near the homesteads. The reason is due to its proximity to the urban area (Debre Tabor).

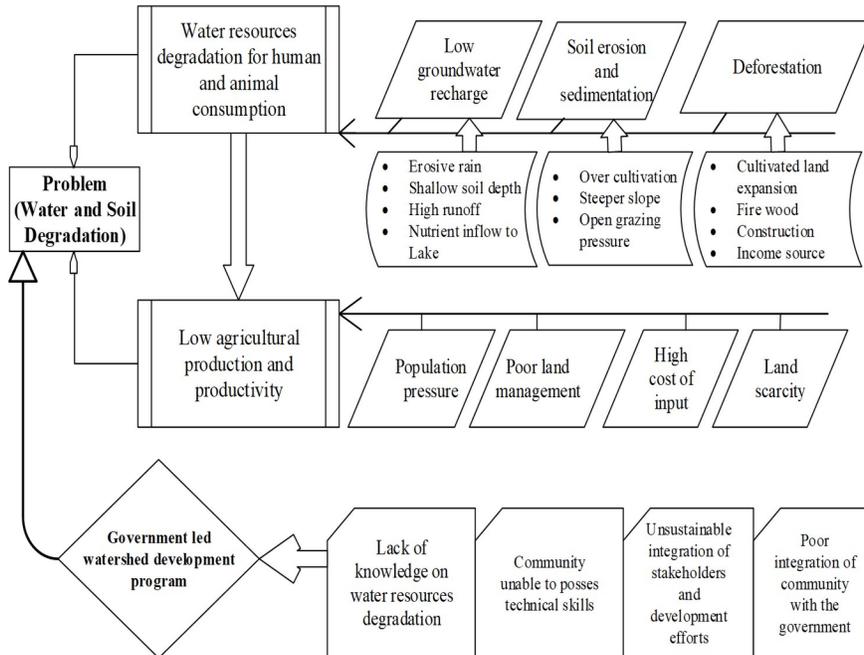
The soil and water degradation (SWD) in the watershed remains a challenge. Figure 6 demonstrates the major challenges in SWD in a problem tree. The diagram constituting the major causes determining the SWD in the Gumara sub-watersheds. Here the detail of each cause-effect summarized as follows:

**Community engagement** : because of a variety of factors SWD continues without having a significant impact on previous efforts. Some of the commonly agreed factors raised by the respondents include lack of awareness about water resource degradation, technical skills, and weak and unsustainable integration among stakeholders, engagement of non-governmental organizations, and the government. The following sections go into the details of each community issue (Figure 6).

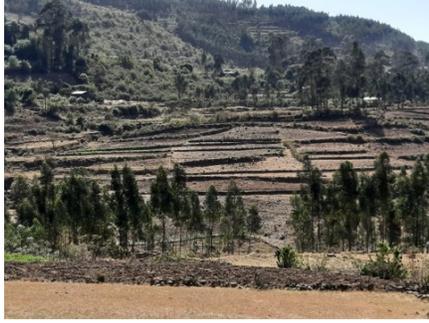
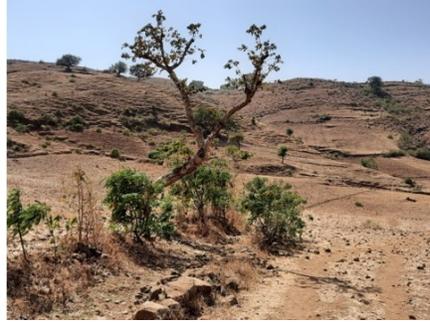
As part of the watershed development plan, the community engaged in four different approaches. The first approach was, the large-scale community mobilized for 25 working days between January and February, annually. Mainly, the practices include soil and water conservation (SWC) works. Secondly, a group of farmers organized to work on conservation works seasonally like gully prevention upon request from farmers. Thirdly, year-round every farmer is assumed to engage in maintenance works on individual farm fields. Currently, the implementation of practices was focused on cultivated lands. According to Farta, Fogera, and Dera offices of agricultural NRM experts, community mobilization is critical to construct numerous structures and cover larger areas. According to farmers in the four watersheds indicated; the approach of involving households in the community mobilization was not considering to respond the concerns of the people rather satisfying the campaign. A farmer who did not participate during the working day either punished birr (600 ETB in Gena, 300 in Girbi except destitute) or arrested for four days. In Wanzaye about 50% of the community participated in punishment. In particular, enforcement was common around Wanzaye. The urban villagers near Wanzaye and admins in this area mobilized communities irrespective of their land ownership in the watershed. The reason was, these communities being benefited from the watershed directly or indirectly. In the same watershed, experts reported that all areas of the watershed covered with SWCP, however, communal and individual farmlands were observed bare (Figure 7).

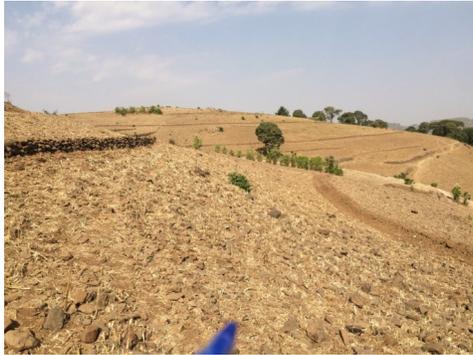
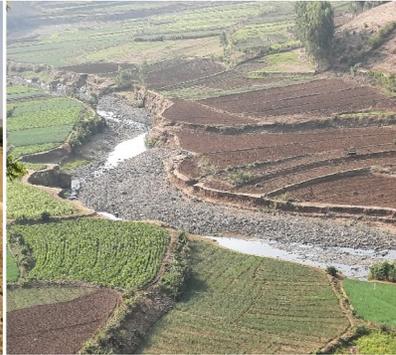
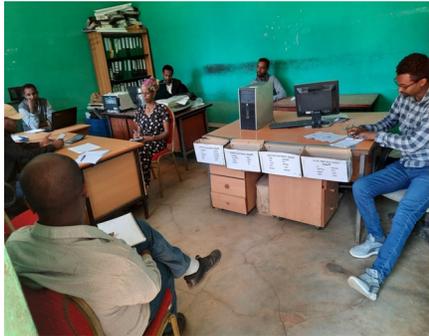
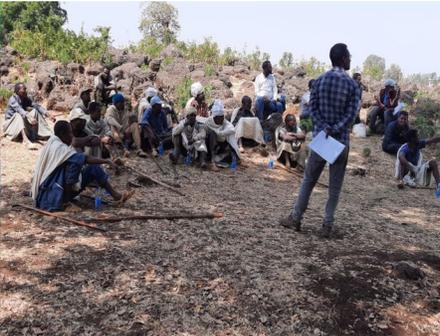
During the study period, farmers were engaged with SWC measures. The layout of conservation structures done by trained farmers selected among the community. These farmers surveyed the installation of SWCP. According to the response from trained farmers on the question of how they made the spacing between bunds and contour lines; they said, "the kebele experts told us to make a spacing of bunds about 10-12 m if the land is a gentle slope and reduce the spacing depending on its inclination (Figure 8)." As a result, the observed structures were made of subjective spacing than keeping its standards.

- The layout of structures was not technically oriented
- The spacing and vertical interval of bunds were not consistent and vary from one to the other
- Contour lines of structures dismantled since smallholders impacted by the layout during plow
- No proper design of structures resulting farmers do their best without professional advice
- Conservation works began at the middle of the field and replacement of old bunds with new ones
- Broken bunds observed during construction not included as a maintenance plan
- Poor link of the bunds with natural or artificial waterways and others
- Farm fields plowed to the edge of the riverbank, causing the land to quickly crumble each year (Figure 8).
