# Demonstration of a Rocking Prosthetic Mitral Valve Using 3-Dimensional Echocardiography and Live Surgical Imaging

July 29, 2021

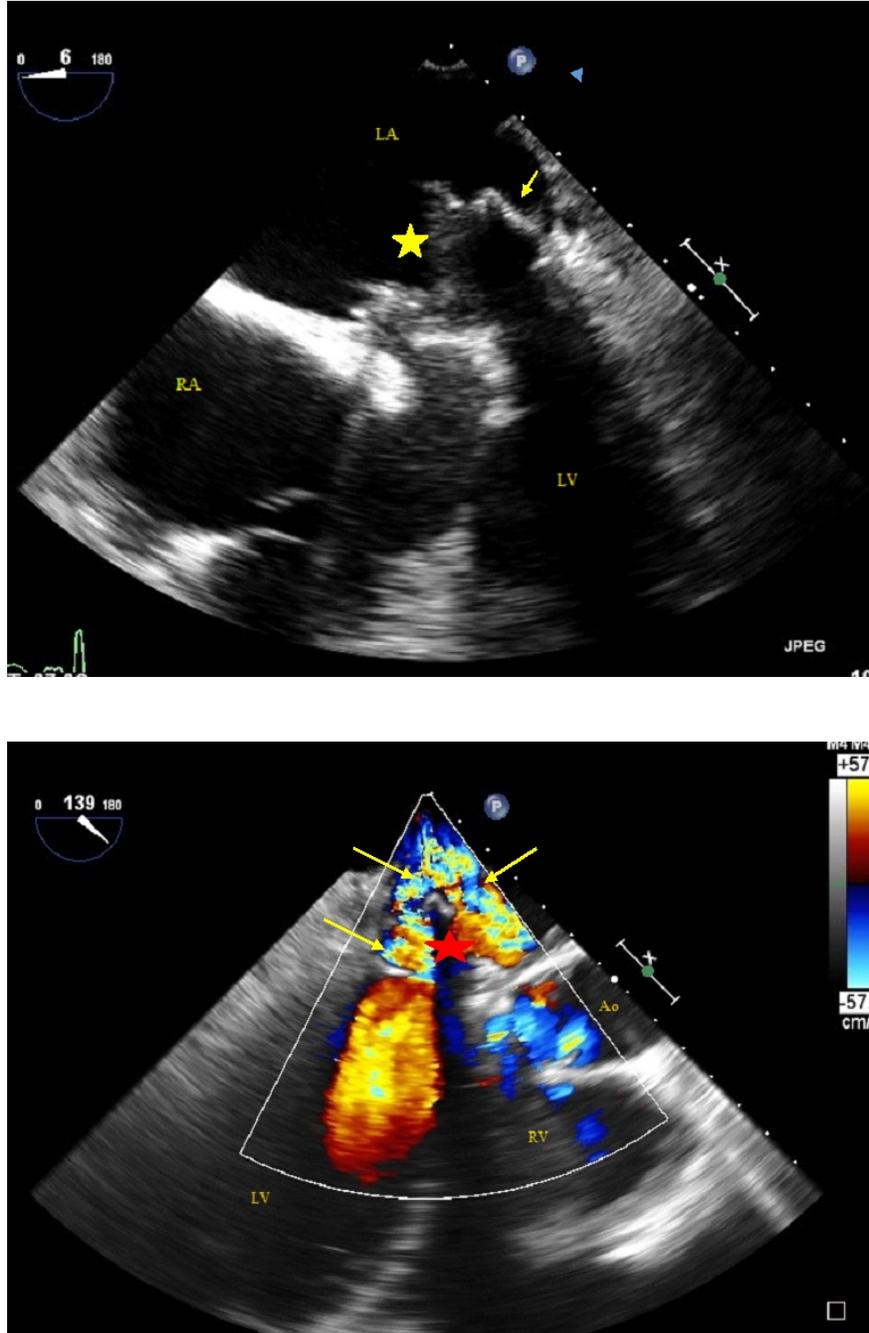
7. Figures: Figure 1: Midesophageal 4-chamber view in mid-systole showing rocking of the posterior portion of the mitral prosthesis during ventricular systole. LA: Left Atrium, LV: Left Ventricle. RA: Right Atrium. Arrow: Area of prosthetic mitral valve dehiscence. Star: Prosthetic mitral valve orifice
