# Line It Up – Inadvertent Placement of Nasogastric Tube in Pleural Space Resulting in Iatrogenic Empyema

July 3, 2021

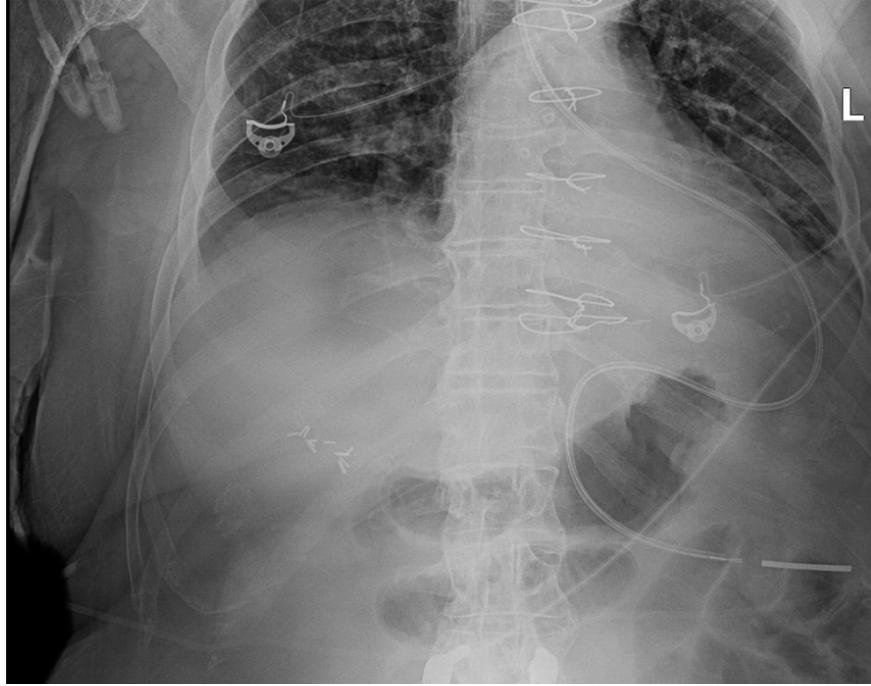
A 66-year-old male with several comorbidities presented with altered mental status and septic shock requiring a prolonged stay in the intensive care unit. A nasogastric tube was placed and confirmed via visual observation on consecutive abdominal radiographs (Figure 1, Figure 2); tube feeding was subsequently initiated. Within a few hours, the patient began experiencing desaturation episodes with an emergent computed tomography (CT) of the chest and abdomen (Figure 3, Figure 4), revealing a new left hydropneumothorax and pleural effusion from iatrogenic puncture of pleura. Tube feedings were stopped and a chest tube was placed immediately with drainage and eventual seal.
