# Acute Iatrogenic Complications After Mitral Valve Repair

## Abstract

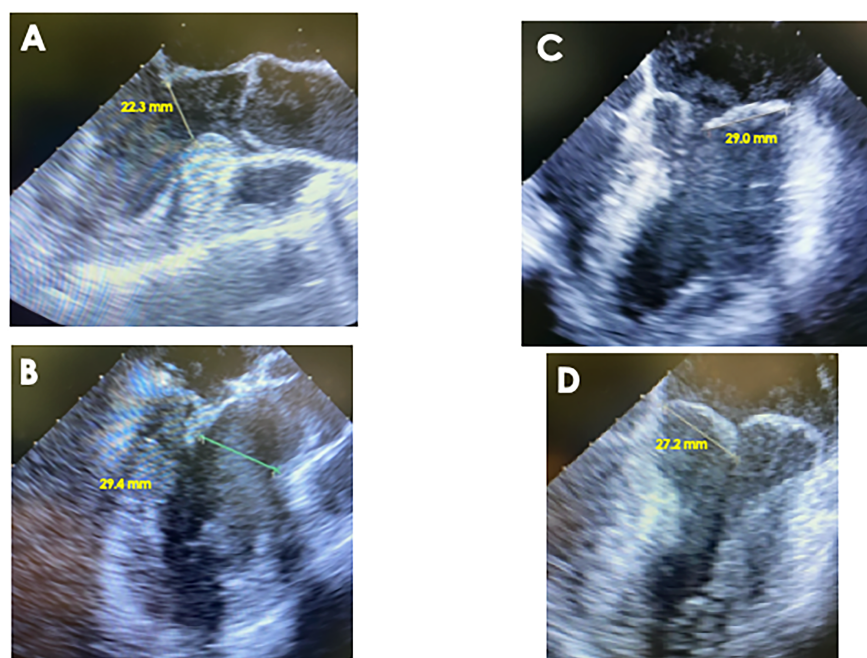
Figure 1 – A, preoperative measure of a C-Septum distance inferior to 25 mm. B, C-Septum distance following a successful repair via posterior mitral leaflet resection, sliding, and ring annuloplasty. C, anterior mitral leaflet measure. D, posterior mitral leaflet measure (i.e., slight underestimation: 2.72 cm is the measure of the chord whereas the arc – “true leaflet” is indeed longer). The anterior/posterior leaflet ratio is thus close to 1.

Avoiding SAM is one the goal of surgical repair of the MV. For this purpose, linking echocardiographic information to type of repair is essential. Preoperative trans-esophageal echocardiography (TEE) helps predicting the risk of postoperative SAM. Besides the usual data regarding the severity of regurgitation, the regurgitant jet origin and direction, the presence of a flail leaflet, and the annular dimensions, TEE must advice surgeons about the risk of SAM particularly when abundant redundancy of the leaflets, hypertrophic interventricular septum, and anterior dislocation of the coaptation line during systole are observed. A distance between the coaptation point and the septum in systole (C-Septum distance) inferior to 25 mm, that usually occurs when the height of the posterior leaflet exceeds 25 mm (particularly in the median scallop P2), has been associated with increased risk of SAM after repair [5] (Figure 1). This is a situation typically seen either in young patient with severe myxomatous disease, where the anterior/posterior leaflet ratio is close to 1, or in elderly patients with less abundant leaflet height but accentuated septum hypertrophy. The combination of a smaller LV end-systolic volume, lower ratio of anterior to posterior leaflets heights and presence of bileaflet prolapse are associated with high risk of SAM after separation from cardiopulmonary bypass (CPB) [4].

In these cumbersome anatomical circumstances, goal of the correction has to create a coaptation line positioned posteriorly, towards the posterior annulus, having the anterior leaflet as much as possible extended in systole towards the posterior one. The height of the posterior leaflet needs to be reduced and this can be accomplished by resections of the prolapsing scallop (quadrangular, triangular or any kind of resection) and, in case of >25 mm leaflet, by detaching the remaining posterior scallops from the annulus according to the sliding plasty technique described by Alain Carpentier [6]. When the height of the posterior scallops is extreme (>30 mm) or when there is discrepancy between the height of the remaining scallops after resection and sliding, then shortening of the scallop can be performed by gently removing 5-10 mm of tissue from the posterior part of the scallop before suturing it back to the annulus. An alternative to resections and sliding plasty is to fold the posterior leaflet towards the posterior annulus with several stiches in order to reduce leaflet length and mobility [7].

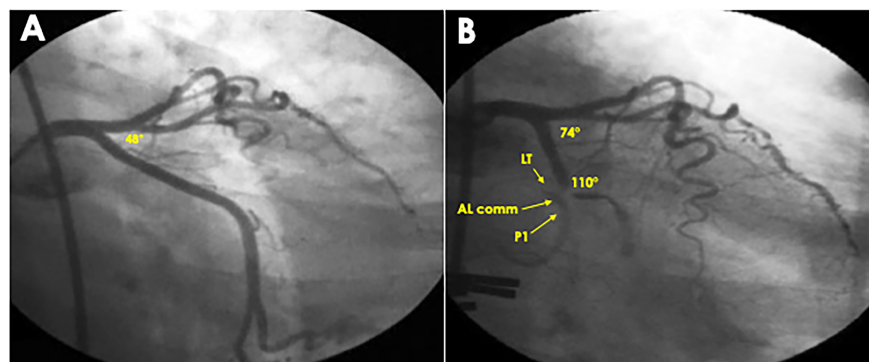
Figure 2. Coronary angiography. A, preoperatively, the angle between the CX and the LAD was narrow ( $48^\circ$ ), anticipating a course of the artery far from the mitral annulus. B, before discharge, the SVG to OM was well functioning (not shown). The angle CX-LAD increased to  $74^\circ$  and the CX itself was severely distorted (angle  $110^\circ$ ). This was possible because the CX was far from the mitral annulus. This patient had a previous endocarditis, which could have caused atrial wall stiffening. From Calafiore et al. [29], with permission.

CX: circumflex artery, LAD: left anterior descending artery, OM: obstruse marginal artery, SVG: saphenous vein graft.

MV repair can be associated to the danger of CX injury (direct damage by sutures), due to the close spatial relationship between the CX and the mitral annulus. The artery is involved in the great majority of the cases in its proximal portion, close to the anterolateral commissure or P1, where the distance between the artery and the annulus is the shortest [11]. Patients with larger CX diameter seem to be more exposed to this complication, as the distance to the annulus reduces [12]. Another mechanism is CX distortion, where the CX is attracted toward the annulus when a misplaced stitch is tied causing severe flow reduction till functional occlusion (Figure 2). In this case the CX has to be far from the annulus, but other contributing factors have to be present, as the atrial wall has to be enough stiff and resistant to move the CX toward the annulus without tearing.

Spatial relationship between the CX and the mitral annulus have been widely studied. Most of the reports showed that the CX is closer to the annulus in presence of left dominance or codominance, but, according to Pessa et al. [13], independently from the dominance, the proximal CX can be as close as 1 mm to the mitral annulus at the level of the anterolateral commissure. These data were confirmed by Caruso et al. [14], who found that 66.7% of the patients considered at high risk (mean distance CX-annulus <3 mm) had right dominance. However, Kishimoto et al. [15] found that the distance CX-annulus is 3 mm or less in 25% of the patients overall, but in presence of a left coronary dominance the percentage rose to 75%, whereas the prevalence was more or less similar in patients with left co-dominance (26%) or right dominance (17%).
