Reel syndrome, Lead Macrodislodgement.

Lead Macro dislodgement (LMD) is a known but less frequent complication of Cardiac Implantable Electronic Devices (CIED) implantation with a range of presentation timelines, depending on the mechanism. We report a case of an unusually late presenting Reel type LMD in an elderly woman.

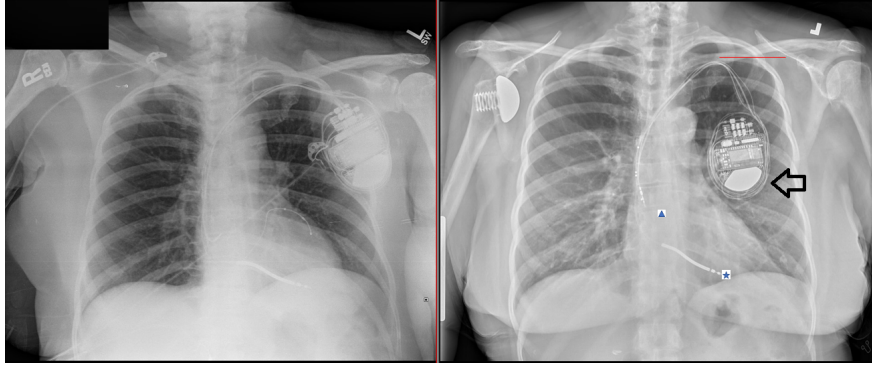
Figure 2: (A) Chest X-ray with intact leads and well positioned generator under the left clavicle. (B) The generator has been displaced medial-caudally (arrow) and leads wrapped around untwisted proximal migration of leads (triangle) except for RV lead (star).

Her pre-op chest x-ray (CXR) (Fig 2 panel B) revealed migration of RA and LV leads into the superior vena cava - right atrial junction. Leads were noted coiled around, while generator was displaced caudally- medially when compared to the original sub clavicular location (Fig 2, Panel A). The RV lead, however, remained well positioned. After informed consent, a mutual decision was made to proceed with leads revision/extraction and re-implantation in the EP lab. We used mechanical Evolution® Shortie RL (Cook Medical LLC, Bloomington, IN), EZ™ stylet (Philips, Andover, MA), and Bulldog Lead extender (Cook Medical LLC, Bloomington, IN) to perform a complete successful transvenous extraction of dislodged RA and LV leads. On gross examination, both extracted leads showed no signs of fracture or insulation break, except for RA lead which had adhesions at mid-segment and dense calcifications at distal end. The original CRT-D generator was replaced with single chamber ICD generator and connected to her original normal functioning DF-4 right ventricle lead.

Figure 2: (A) Chest X-ray with intact leads and well positioned generator under the left clavicle. (B) The generator has been displaced medial-caudally (arrow) and leads wrapped around untwisted proximal migration of leads (triangle) except for RV lead (star).
